The Falcon Group

Hudson Club Condominium Association

Terrace Replacement

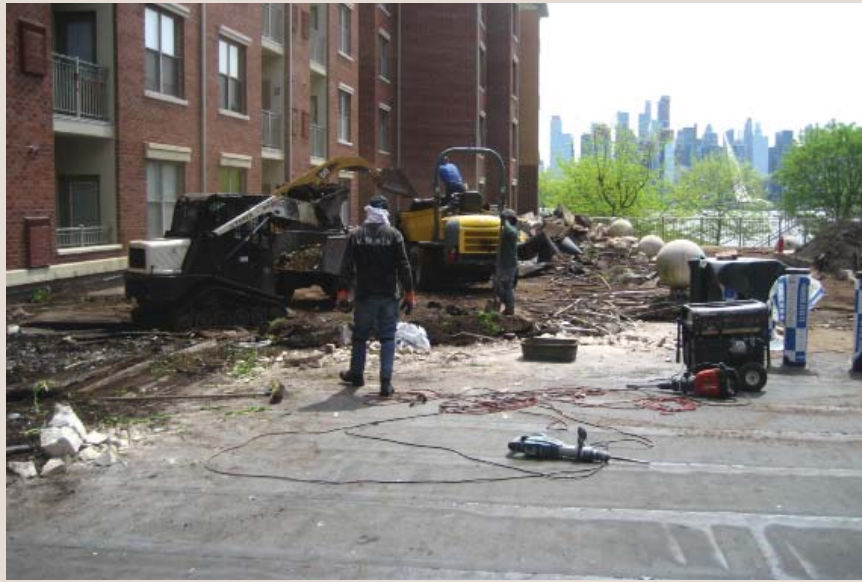
During Demolition

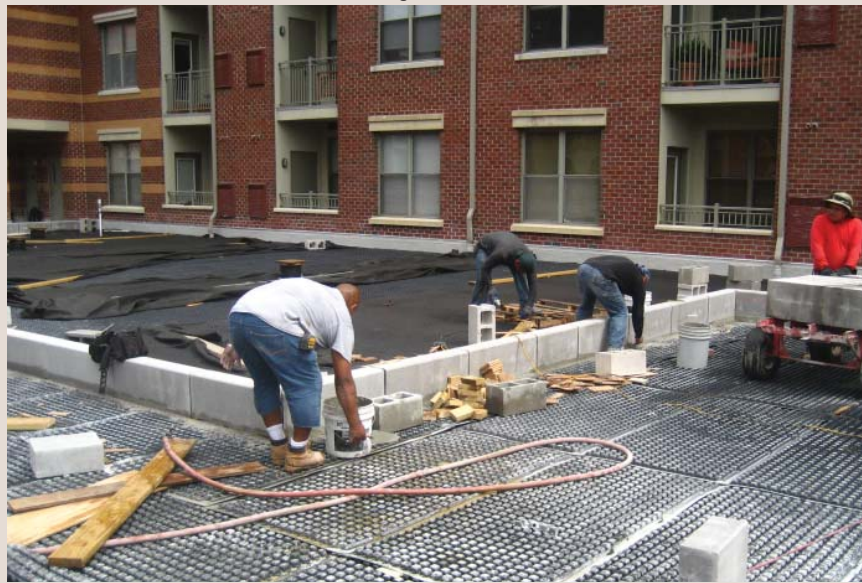
During Installation

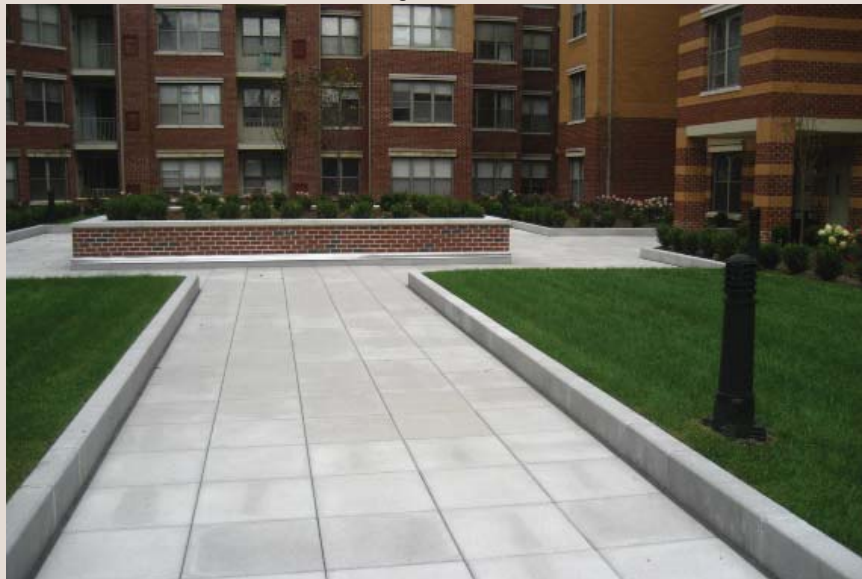
After
