## *Pinecrest Office Park*

*Roof Improvements*

Falls Church, VA

6-Commercial Office Buildings

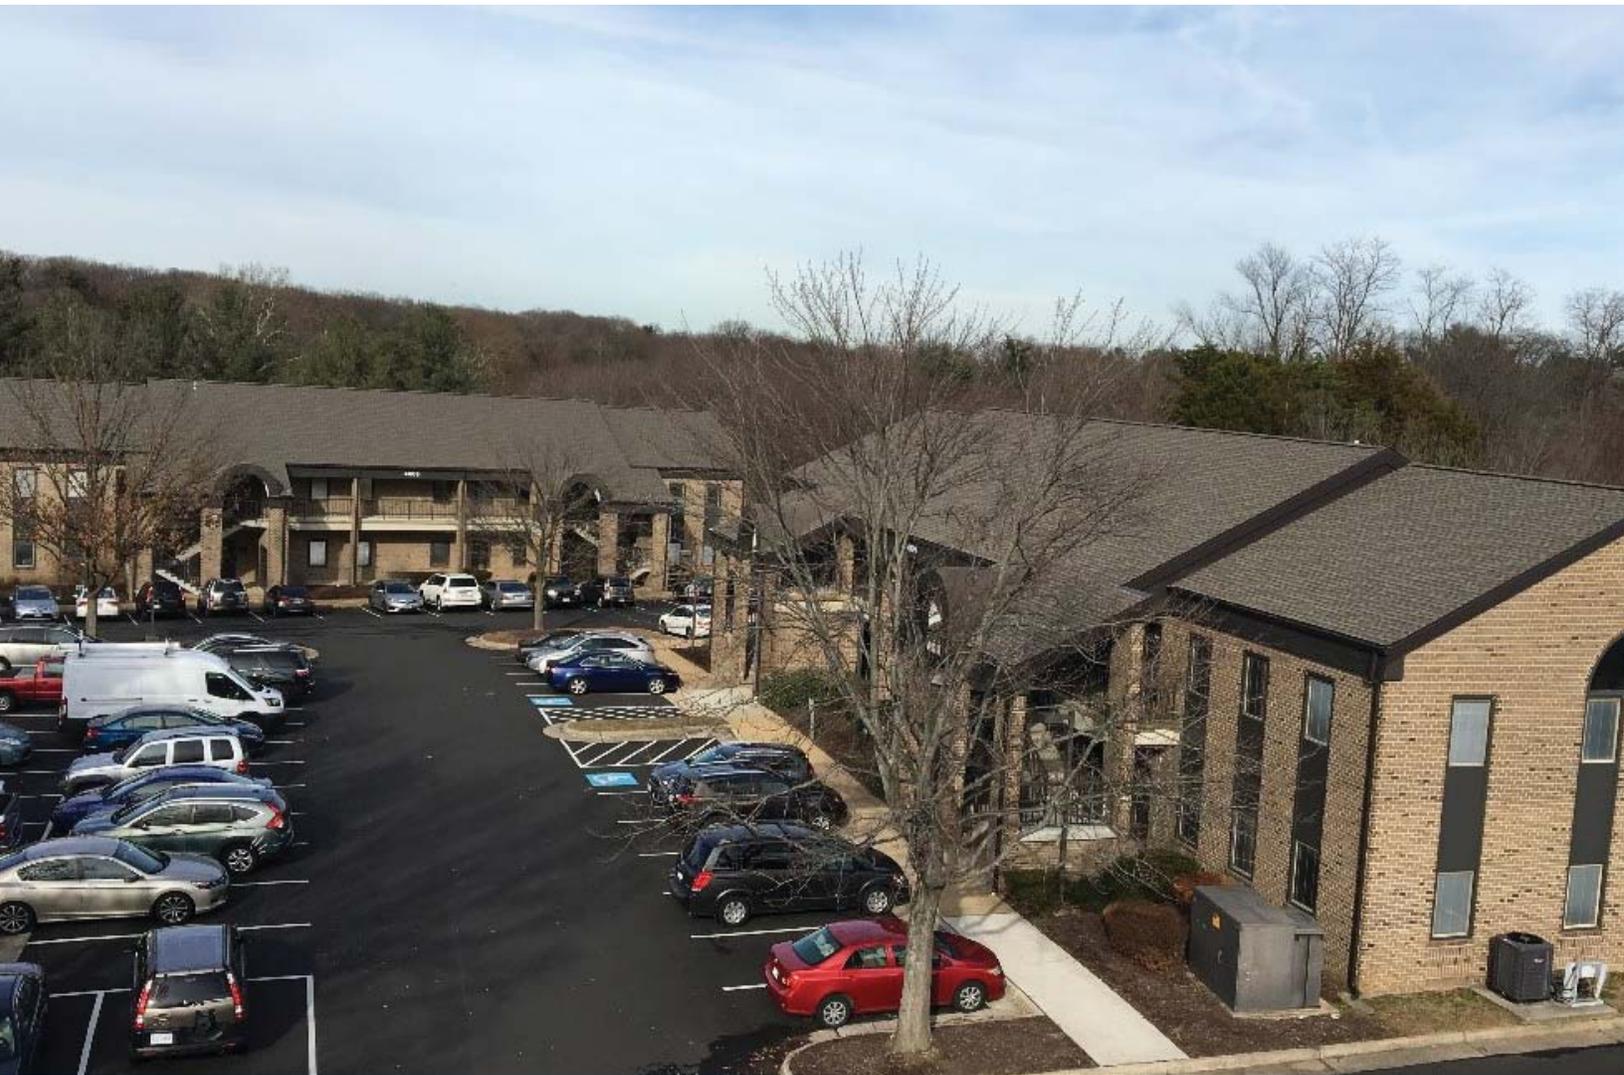
Pinecrest Office Park is located in Falls Church, Virginia and is made up of 6 Commercial Office Buildings.

During the initial investigation, it was determined that the existing metal panels on the roof were in fair condition with some level of remaining useful service life.

However, Falcon found that there had been a significant number of miscellaneous holes, openings and seams created throughout the entire metal roof structure permitting a rather significant amount of water intrusion into the attic space.

Damage to the roof supporting frame was found to be significant and with the potential for further damage to the roof if left unattended. Falcon presented the Owner with the options for the roof structures to be replaced either in kind with new standing seam metal roofs or with new heavy duty asphalt shingles.

Ultimately, the decision was made by the Board to completely remove and replace the roofing materials throughout the office park with new asphalt shingles.

Additional work included the replacement of a relatively large amount of water damage wood roof decking.

Falcon additionally recommended the removal and replacement of the existing soffit ventilation systems, new ventilated metal soffit paneling, and that the existing configuration be altered to allow sufficient ventilation. As installed, the existing metal soffit opening offered virtually no fresh air intake, which is vital for minimizing the accumulation of moisture below the roof.

By installing the roof ventilation systems, the Falcon Team and the roofing contractor were able to provide the proper, required ventilation in the attics.
