Riverside Condominium Association

Roof Replacement

Cranford, NJ

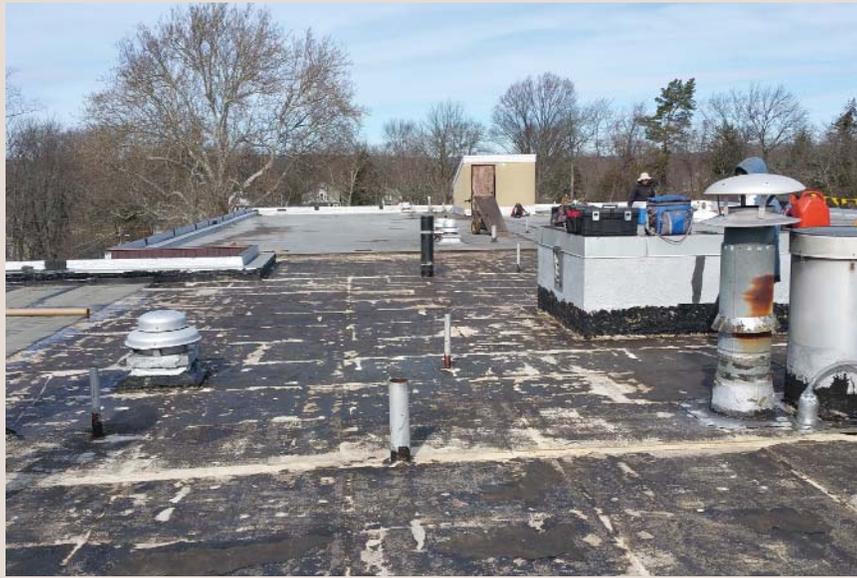
Before

This project included the complete removal and replacement of the existing low-slope modified bitumen roof system. There were improper flashing conditions at roof perimeter and penetrations that led to water infiltration into the units below.

The roof itself also had insufficient slope which created ponding water conditions that expedited the deterioration of the existing roof. A felt-backed PVC membrane with full tapered insulation system was specified for the new roof assembly. Proper roof slope would be provided by the tapered insulation and the PVC membrane provides excellent durability & performance.

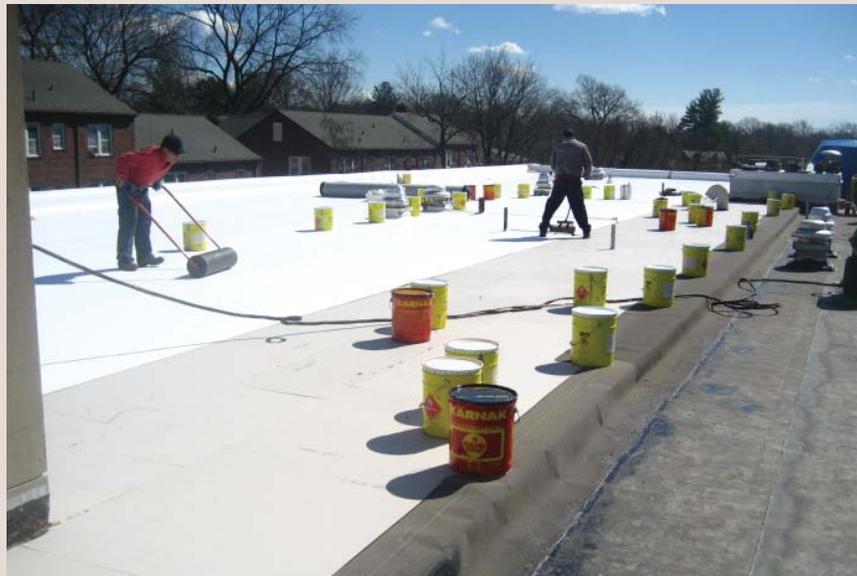
During

Due to the complexity in installing a full tapered insulation system, Falcon specified the use of a torch applied modified bitumen membrane which was installed directly to the concrete roof deck. This membrane acted as a temporary roof allowing the roofer to easily phase the work and speed up production. The felt-backed version of the PVC membrane was also used to provide greater puncture resistance and allow the membrane to be adhered in a 2-part urethane adhesive which can be used in colder temperatures and allow the work to continue into the winter.

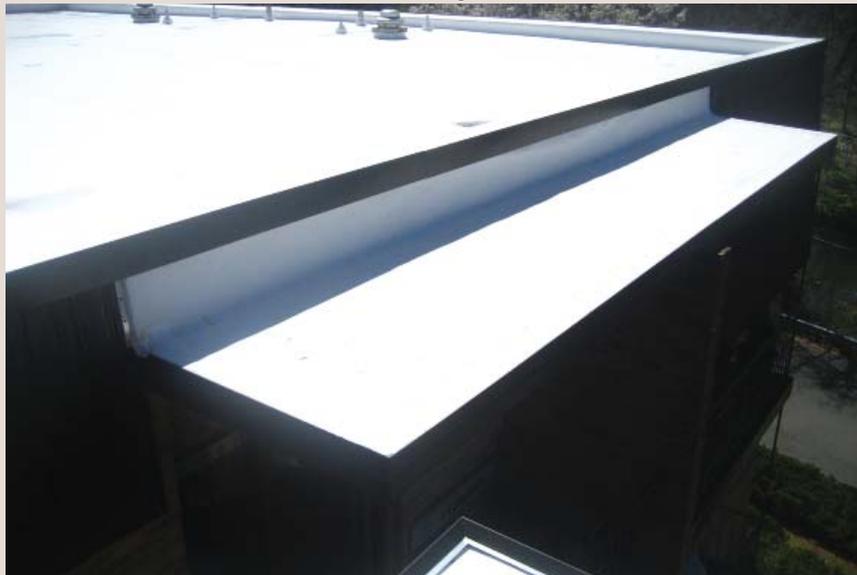
After

The project was completed under budget and on time. The Client was provided a new roof system that addressed all the previous roof leaks and has a 20-year manufacturer's warranty to cover the materials and workmanship.
